**ALABAMA HAZARDOUS WASTES MANAGEMENT AND MINIMIZATION ACT
(AHWMMA)**

Compliance Evaluation Inspection (CEI) Report

Hyundai Steel America, Inc.
200 Team Member Lane
Greenville, Butler County, Alabama 36037

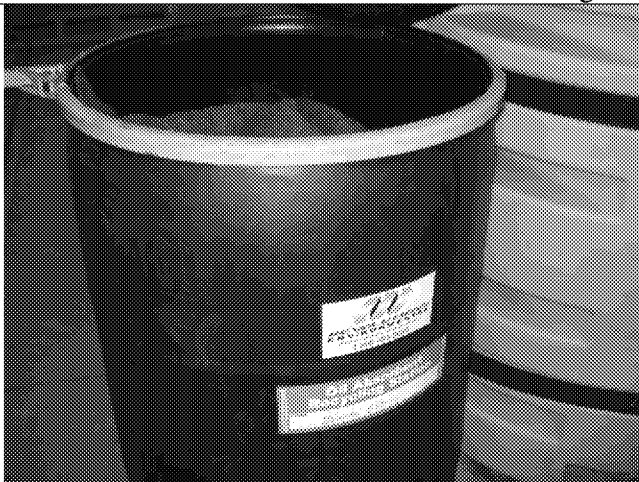
Stamped pieces of mild steel are MIG-welded to create specific shapes. Releases of lubricating oil are absorbed using spill pads, which are then placed in a 55-gallon poly drum. One drum of oil-saturated sorbents was staged in this area; it was closed, but was not marked with the words "Used Oil". See Photograph #2.

2. Unmarked container of oil-saturated sorbents

In an email received on March 30, 2016, Mr. Stewart provided documentation that the drum had been labeled.

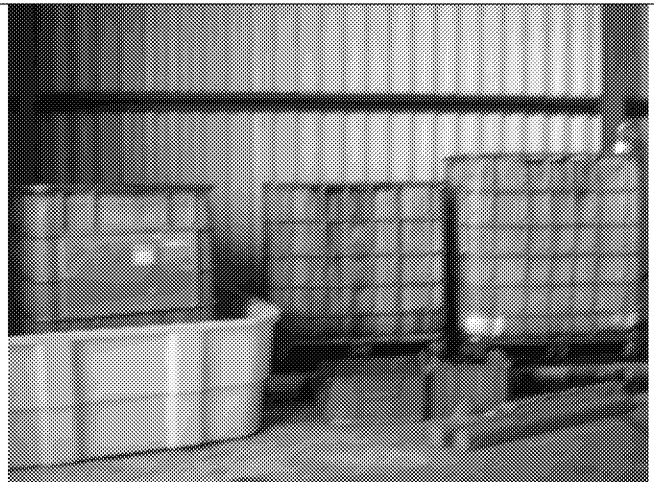
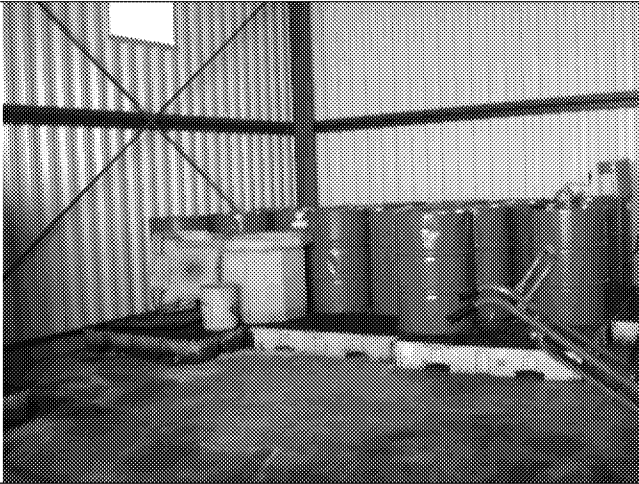
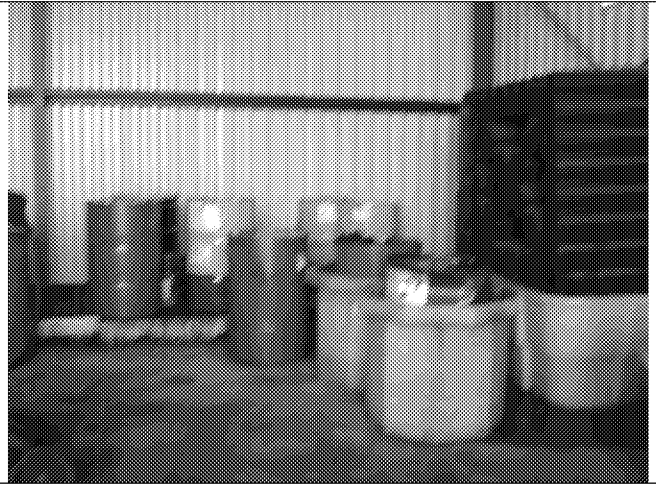
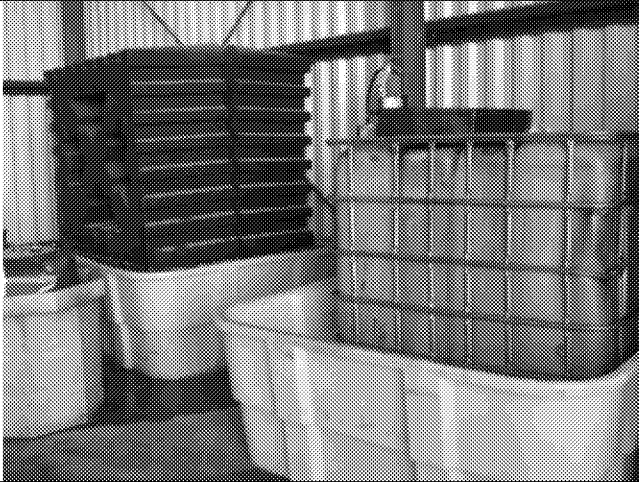
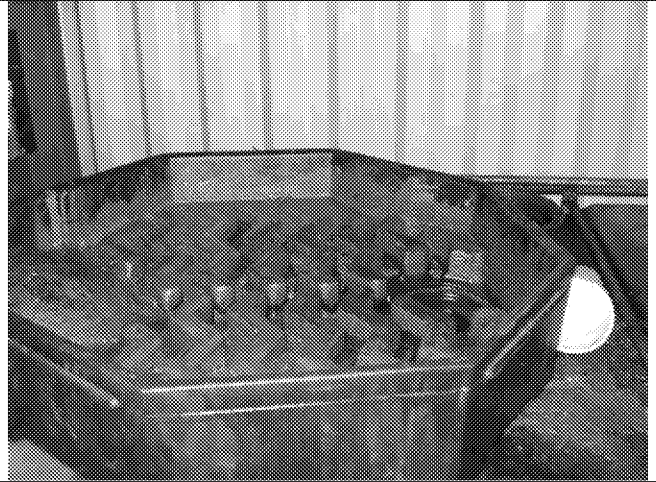
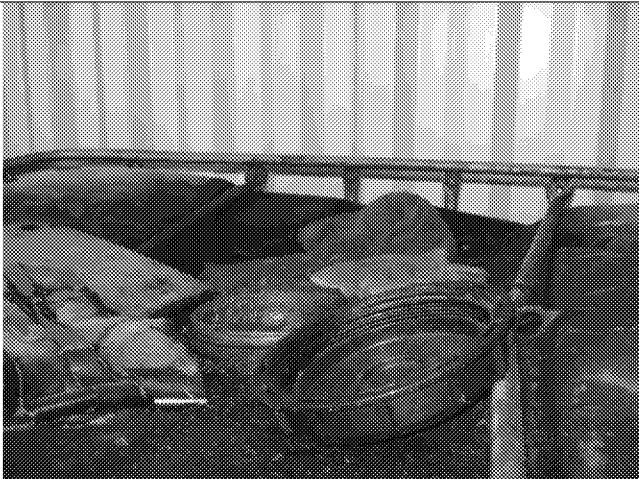
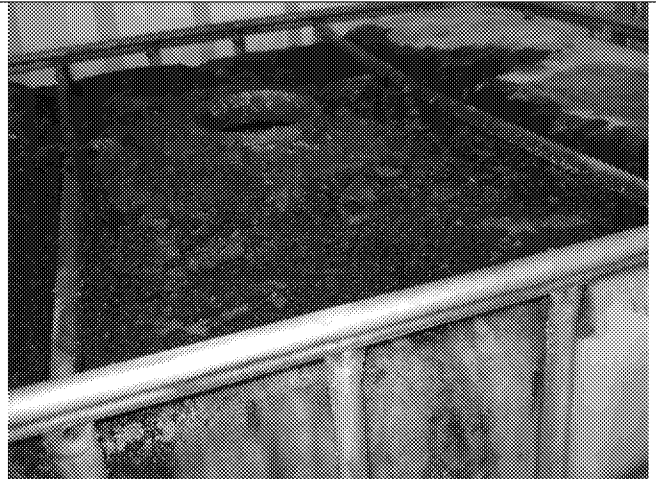
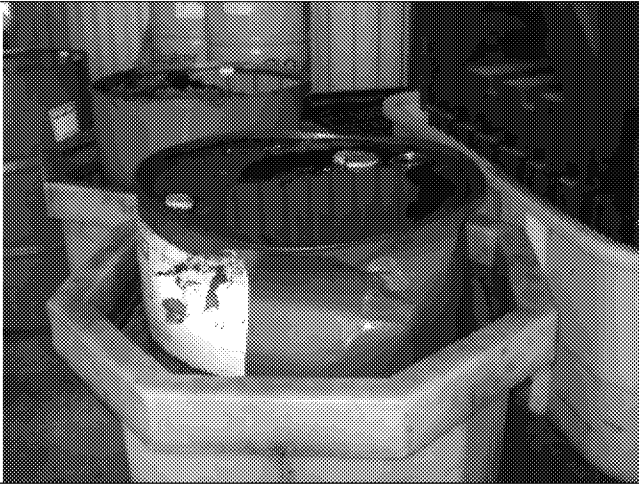
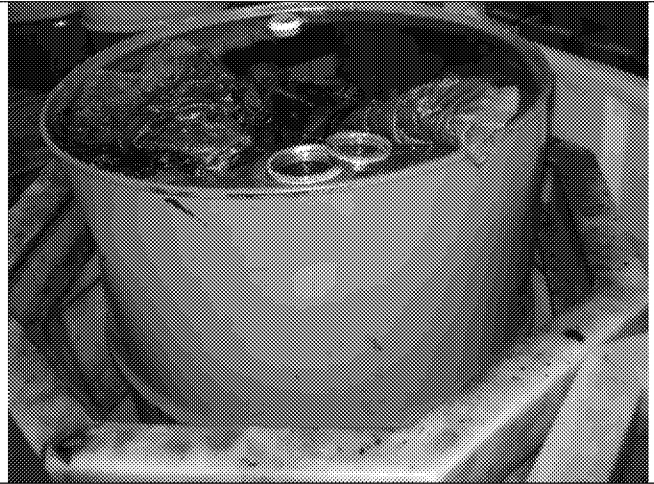
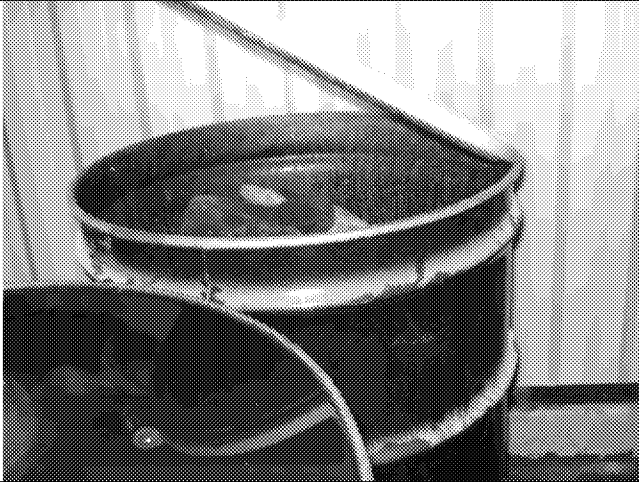
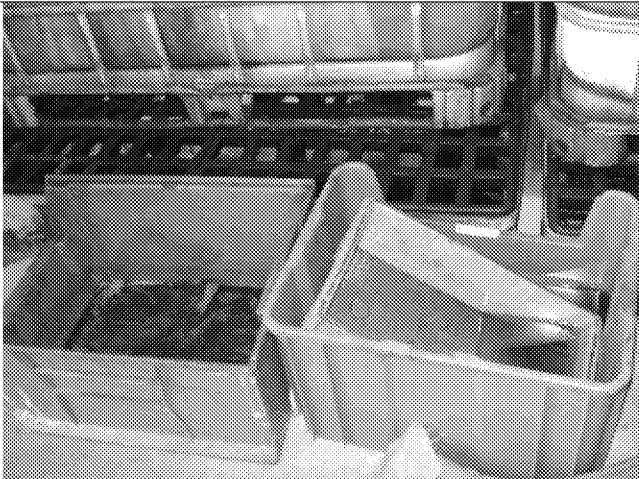
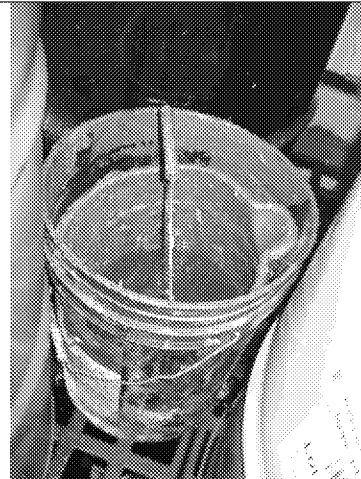
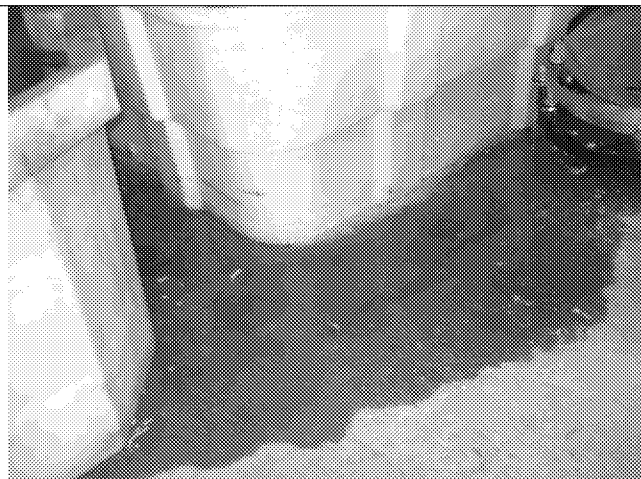
Used oil and oil-contaminated sorbents are stored in a free-standing metal building located outside the northeast corner of the main facility. We saw one open-top 55-gallon drum containing oil-saturated sorbents, four close-top 55-gallon drums, and four 350-gallon totes containing used oil, and one 55-gallon drum equipped with an aerosol can puncture unit; all of the drums and totes were staged on or in spill containment units. Eight spill containment units, one 5-gallon plastic bucket, and three plastic parts bins also held used oil, and there was a release of used oil to the floor of the building. Some of the spill containment units also held significant amounts of solids, such as oil-dry.

The tops of all four of the drums of used oil were covered with used oil.

Three of the totes and two of the drums of used oil were not closed; the openings were not capped. The drum of oil-saturated sorbents was also not closed; the lid was in place but was not secured.

One drum and one tote holding used oil were not marked with the words "Used Oil".

One drum of used oil was severely damaged; its top and sides were bent and deformed.

The spill containment units, the plastic bucket, and the plastic parts bins were not designed to be used as containers, were not marked with the words "Used Oil", and could not be closed.

The release of used oil to the floor of the building had not been cleaned up.

See photographs #3 through #19.

In an email received on March 30, 2016, Mr. Stewart provided documentation that all drums had been labeled.

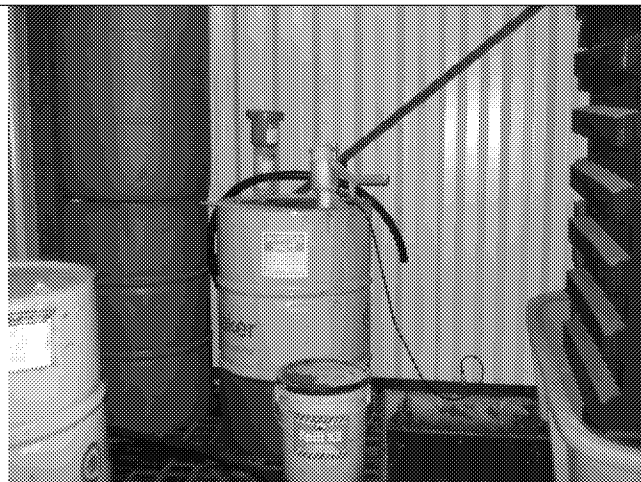
The drum that was equipped with the aerosol puncture unit was labeled with the words "Universal Waste".

19. Aerosol can puncture unit

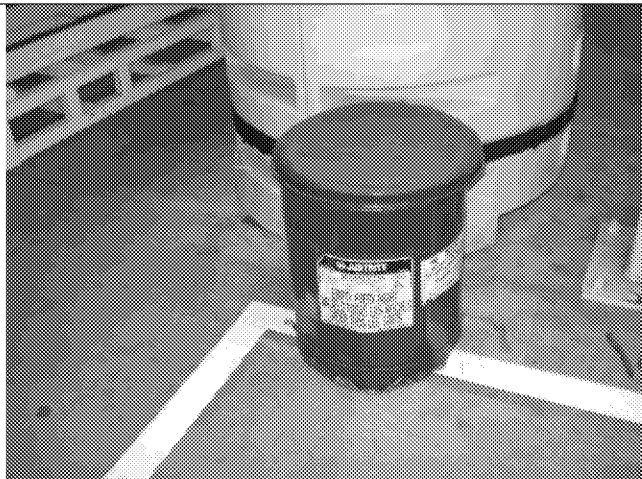
From the used oil storage area, we returned to the main facility and went to the re-work area. Fabrication defects are corrected in this area, but little waste is generated other than oil-saturated wipes. We saw one 5-gallon self-closing container of oily wipes in the area; it was closed but was not marked with the words "Used Oil". See photographs #20.

20. Unmarked container of oil-saturated wipes

In an email received on March 30, 2016, Mr. Stewart provided documentation that the drum had been labeled.

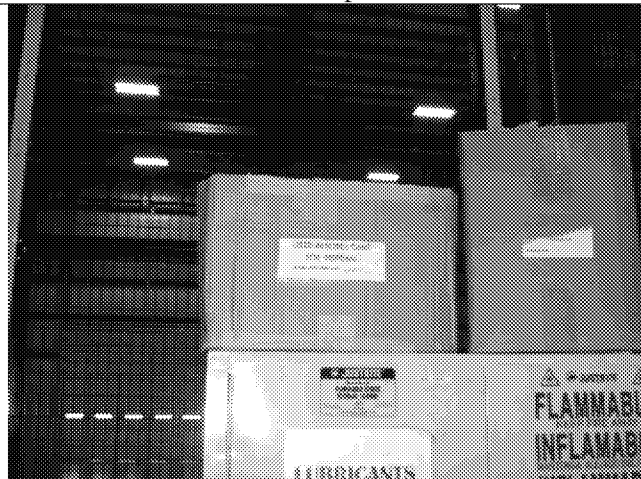
After the Re-work area, we went to the Maintenance shop. Equipment repairs are accomplished in this area, as well as storage of parts and materials. Spent emergency batteries are collected in this area if needed, but none were present during this inspection. Spent aerosol cans of WD-40 and spray paint are collected in the maintenance shop until they are taken to the Used Oil storage building to be punctured. We saw one corrugated cardboard box marked with the words "Used Aerosol Cans for Disposal". The box was closed and in good condition, and was dated December 1, 2015. We did not ask Mr. Stewart to open it. See photographs #21.

21. Spent aerosol cans awaiting puncture

In an email received on March 30, 2016, Mr. Stewart provided documentation that the aerosol cans had been transferred to a closed plastic container.
